# STRUCTURAL ANALYSIS COMPARISON

UNIVERSITY OF MASSACHUSETTS  
AT AMHERST

GRANITE AND PRECAST CURBING

January 1991

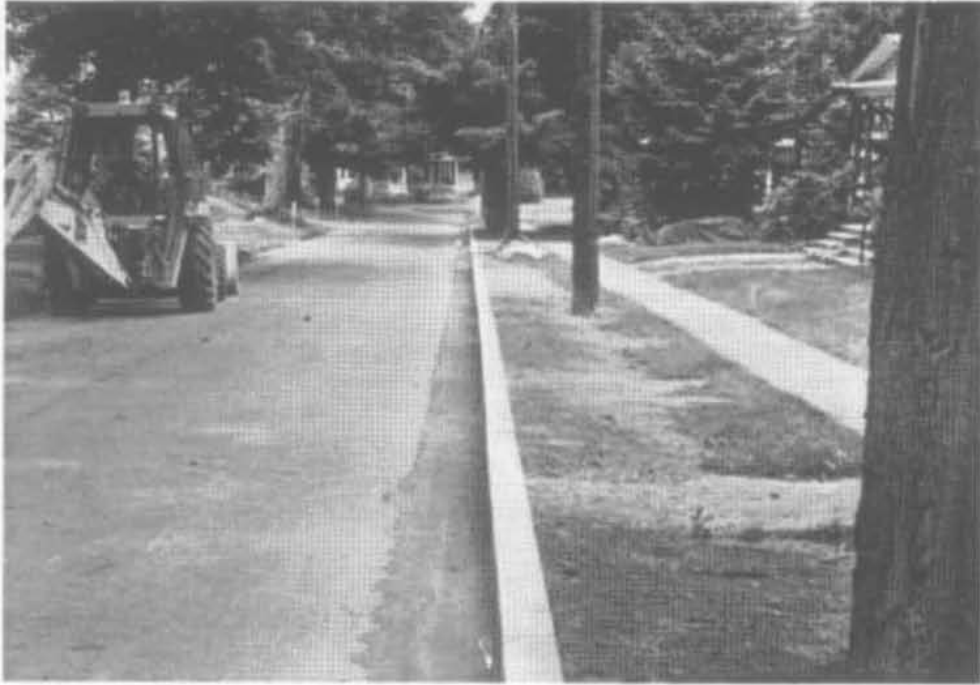
*FIGURE 3: Modern machinery and methods produce granite curbs with neat sawn tops and smooth split faces adding to the aesthetic appearance of the pavement.*

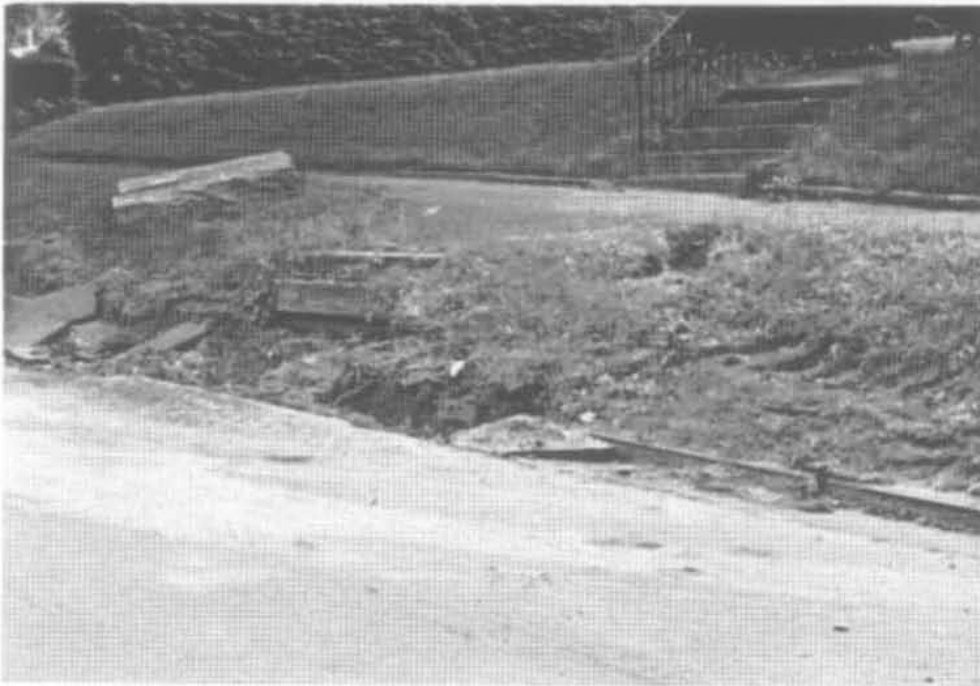
*FIGURE 4: Due to its long life span granite curb can be removed and reset to new line or grade.*

Considering the recycling of curbing material, most highway construction specifications call for granite as a curbing material where salvaging and reuse during highway widening and reconstruction is considered (4).

Reuse of granite is enhanced as it can be cut into different widths and shapes (5). Granite is also used as a facing for precast concrete curbs (8).

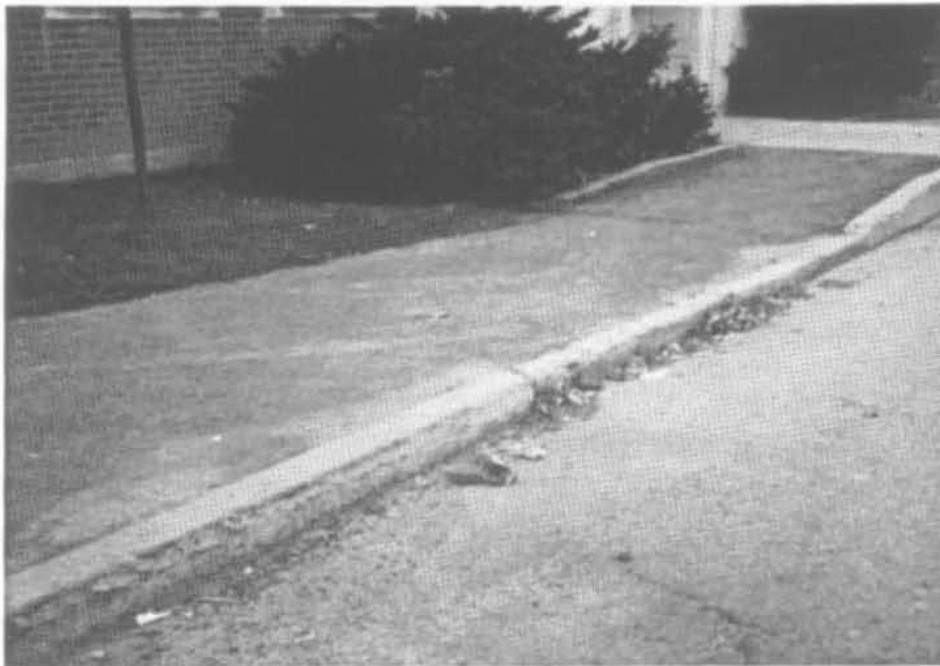
*FIGURE 6: Comparative view of granite (to the left) and concrete (to the right) curbing.*
